Town of Meridian Hills
Drainage Study Report

Prepared for:
Town of Meridian Hills

Prepared by:
The Schneider Corporation
Project No. 4918.002

July 12, 2004

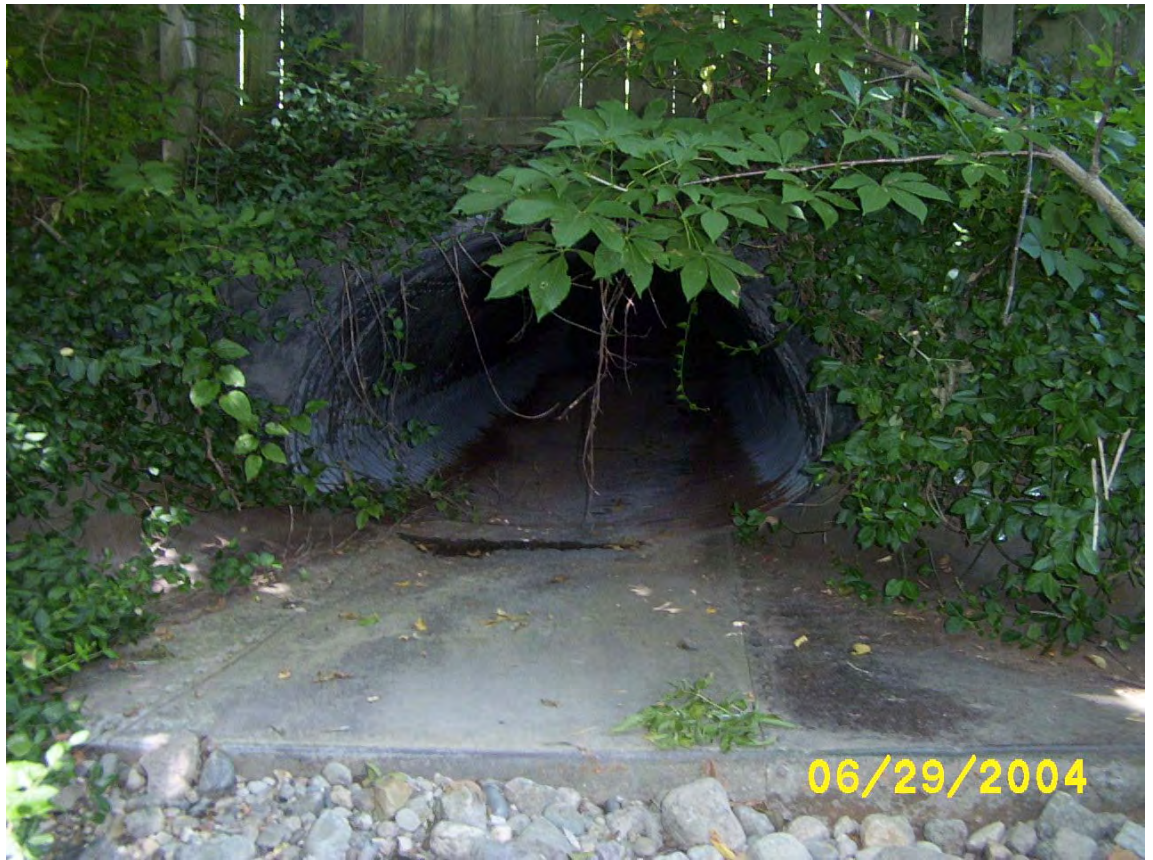
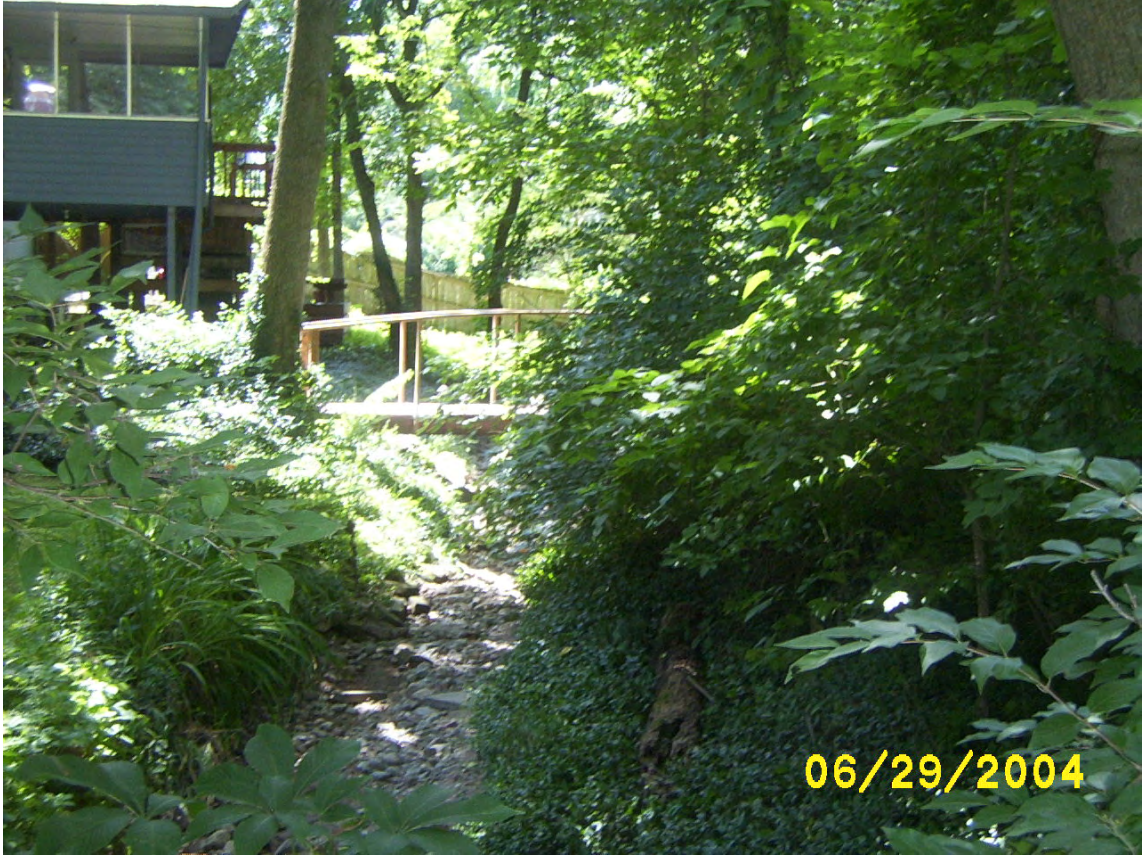
1. 71st Street and Williams Creek Drive

Periodic flooding is due to inadequate conveyance capacity in the existing drainage system. This area is located at the downstream end of Basin C. A relatively large area, approximately 470 acres, drains to this point, with a potential to produce an estimated 10-year peak flow of 280 cfs if flow is unimpeded upstream. Large volumes of storm runoff generated upstream must either be temporarily stored in detention ponds or effectively conveyed to Williams Creek. Since storage requires additional real estate and does not appear to be an option, adequate conveyance is essential to minimize flooding of adjacent properties. Due to the relatively large drainage area, serious flooding can occur if flow conveyance capacity in the stream channel is deficient or if it has been reduced by obstructions, poor maintenance, or encroachments.

The current outlet is a 230 ft long, 38" x 60" structural plate pipe arch that daylights in the Williams Creek. It appears to be undersized, with flows frequently overtopping the road. The capacity of this pipe flowing full is approximately 95 cfs at 1% slope, and it is not likely to exceed 150 cfs without major backups. At a minimum, a second outlet of comparable size would be required to alleviate street flooding. This would reduce roadway flooding as long as flow is not backed up due to high flood stages in Williams Creek. This area is a designated regulatory floodplain with a base flood elevation of 722 NGVD. Infrequent, but serious inundation of this area as a result of increased flood levels in Williams Creek can be expected to occur regardless of the additional outlet.

A detailed design should address both the conveyance and floodplain issues to confirm the cost-effective solution.

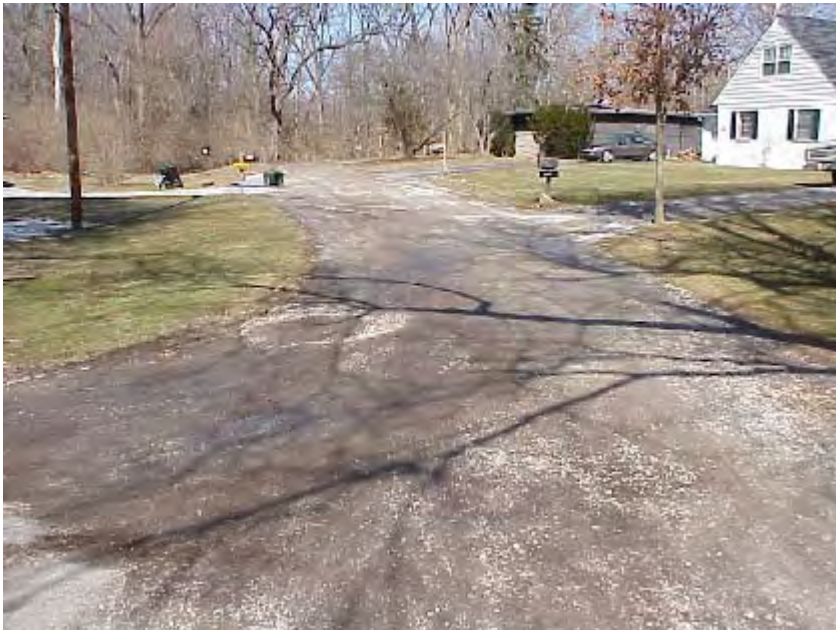
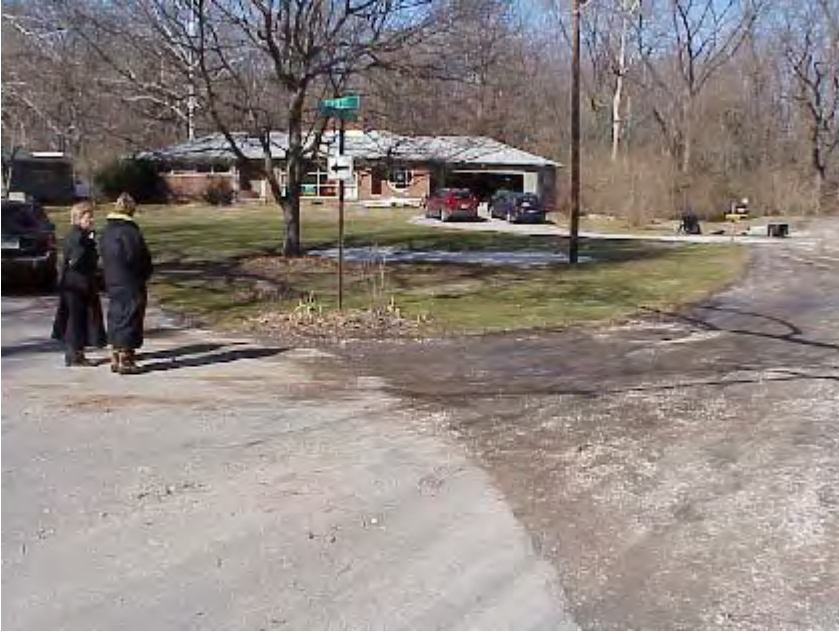
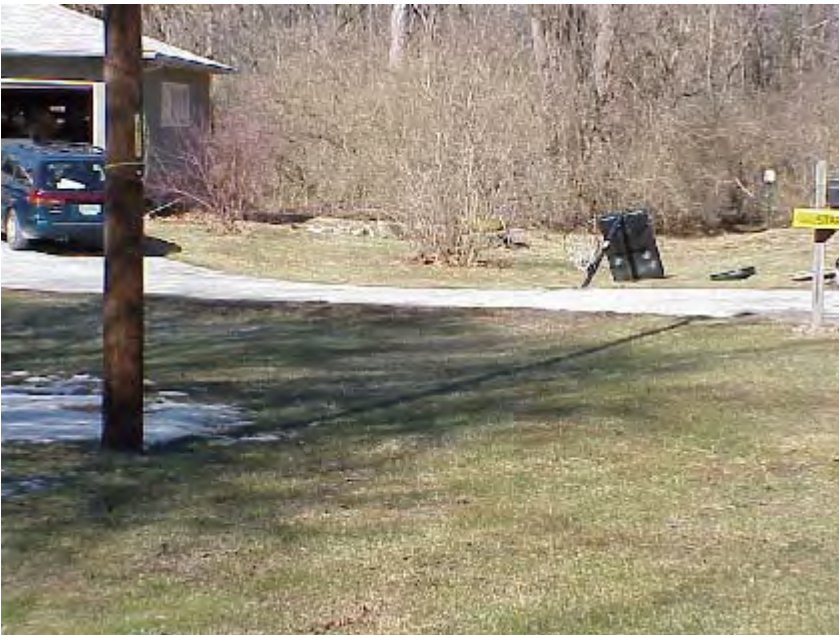
2. 73rd Street and Williams Creek Drive

Williams Creek Drive north of 73rd Street is a gravel road approximately 200 feet long. Approximately 5 acres drain to the intersection, producing an estimated peak 10-year flow of 12 cfs. Standing water in the northwest corner of the intersection has been reported. It appears that construction of a driveway across an existing ditch west of the gravel road may have created or exacerbated the drainage problem.

This is a floodplain area and infrequent, but serious inundation as a result of increased flood levels in Williams Creek can be expected to occur regardless of local drainage improvements.

Local drainage may be improved to allow standing water to drain to Williams Creek. This will require reestablishing a flow line in the ditch west of the gravel road and may require installing a driveway culvert. Drainage in the gravel road will require roadway improvements such as grading and paving.

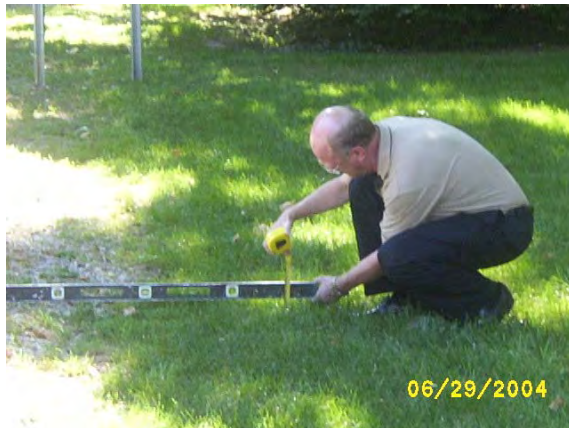
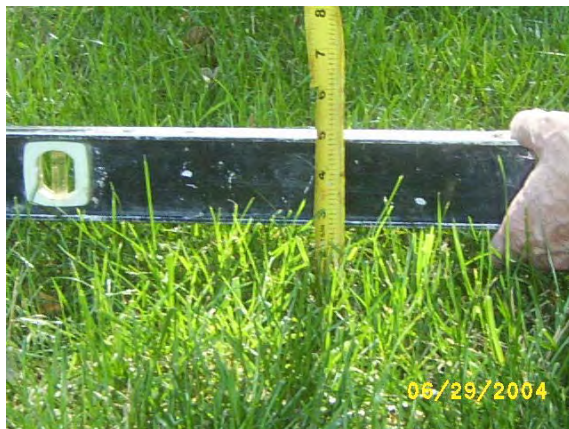
3. 730 Sherwood

Periodic standing water in the front yard appears to be due to flat slopes and a lack of storm conveyance system.

With less than 3 acres draining directly to this area, this problem can be addressed with local improvements. This can be achieved by installing a modified French drain where ponding in the front yard and roadway shoulders occurs, and by providing conveyance through 4" field tile along Sherwood Drive extending approximately 175 feet west to an existing waterway. Also, grading the front yard and roadway shoulder area to provide positive drainage to the road or existing storm inlets should be considered during engineering design.

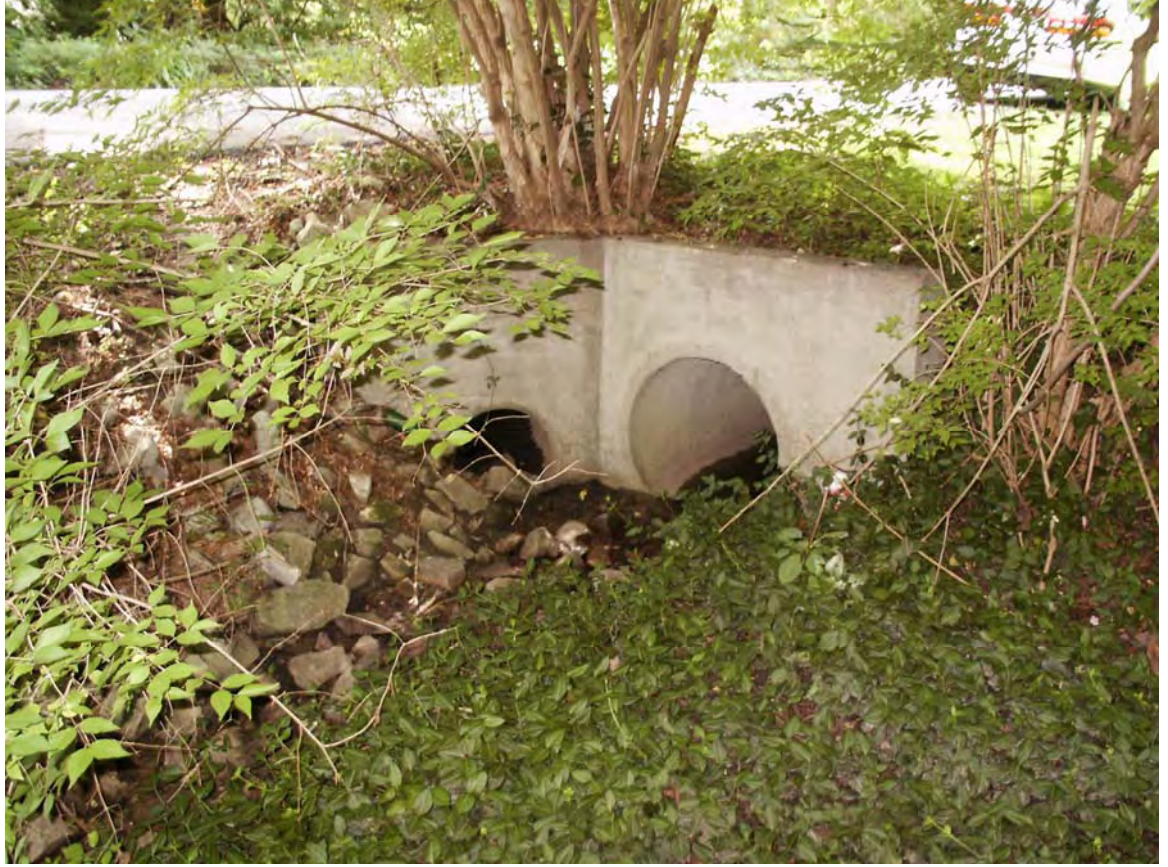
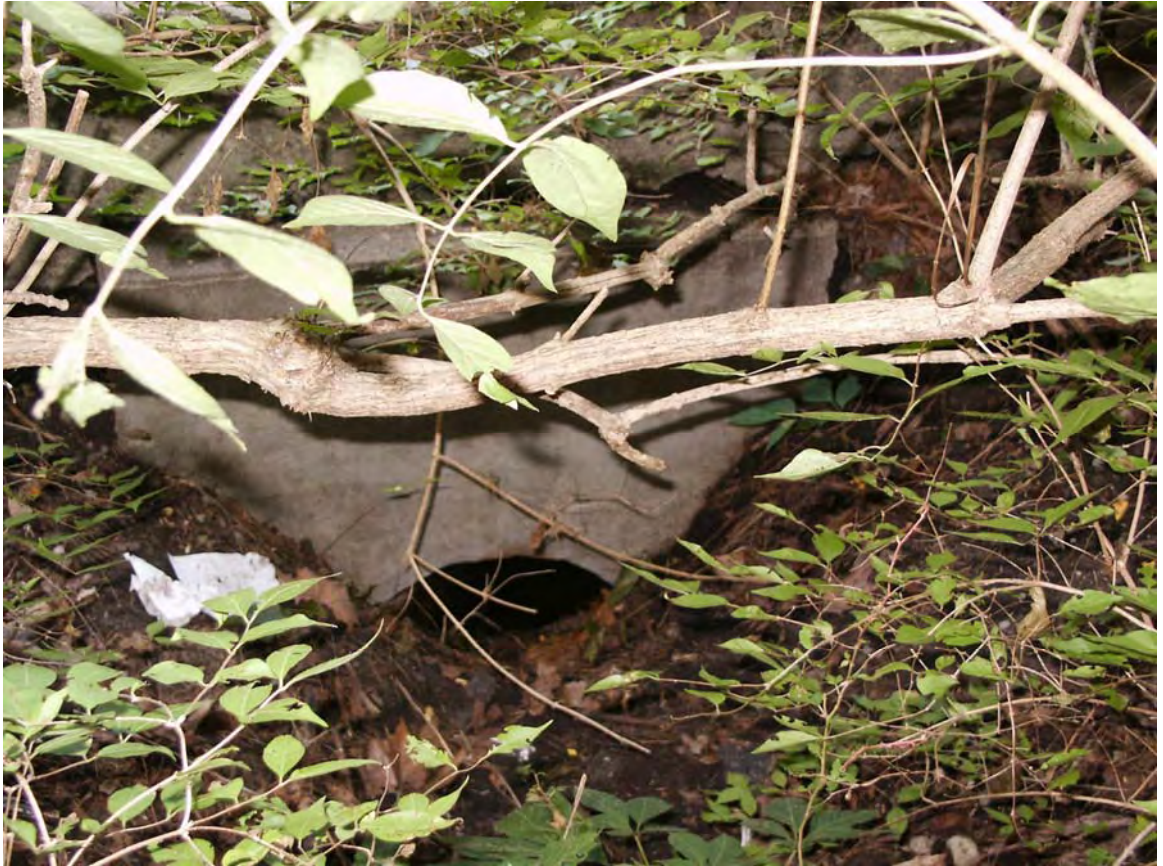
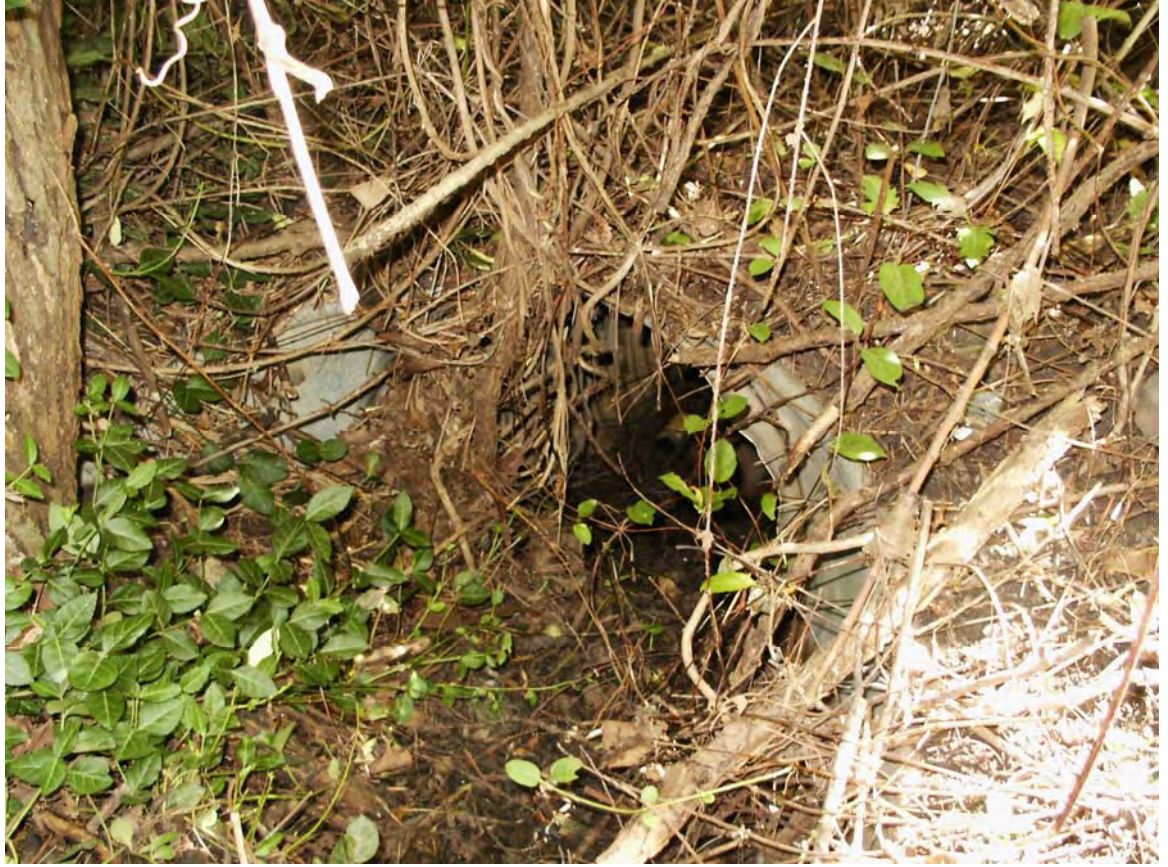
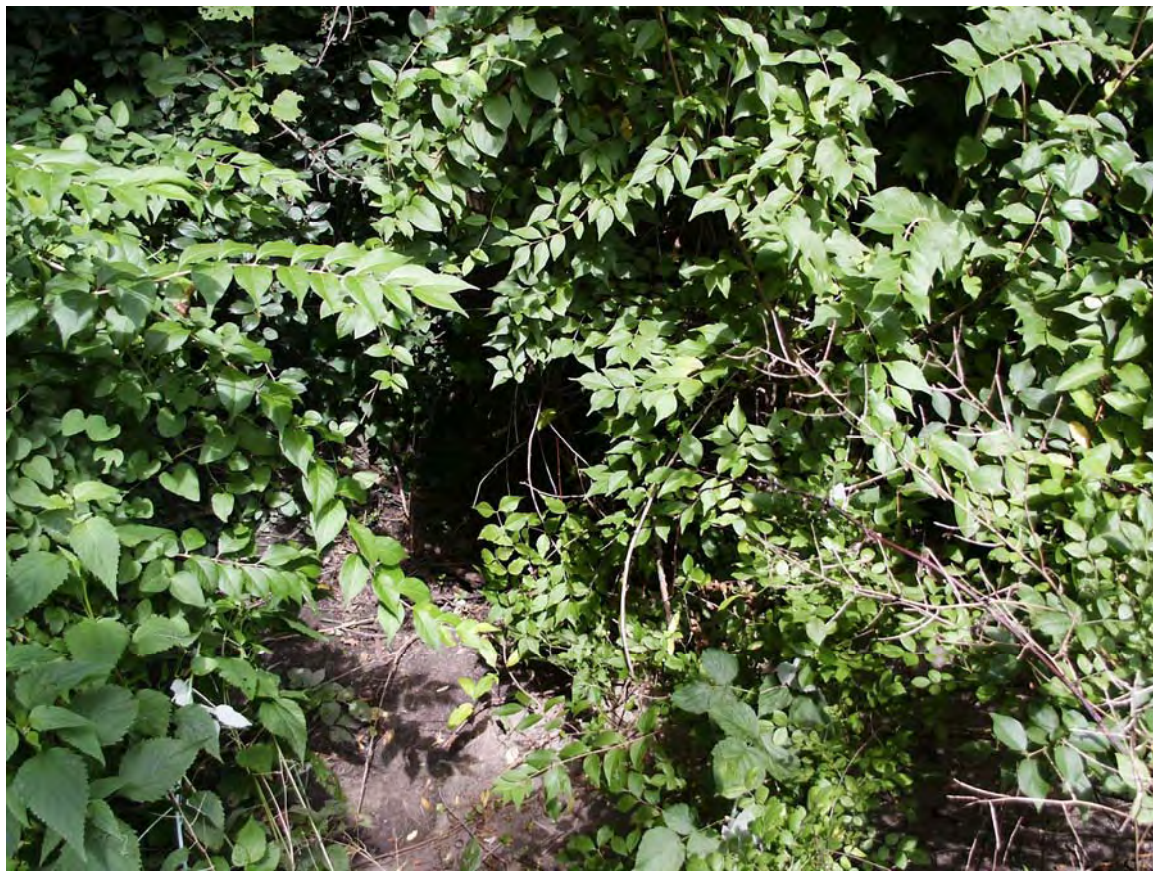
4. 7520 Morningside

Approximately 30 acres drain to the problem area. A steep drainage swale was filled and replaced with a private road and covered storm sewer. Periodic standing water and flooding at this location appear to be a conveyance issue. Generally slopes are moderate to steep. Drainage problems encountered appear to be due to insufficient conveyance and local construction.

The drainage area that contributes runoff to the problem area is capable of potentially producing an estimated peak 10-year discharge of 35 cfs, and large runoff volumes. The actual peak discharge at the problem area may depend on the capacity of the existing storm system. A detailed design is required to make that determination. A survey during design would determine if existing conveyance deficiencies other than undersized storm pipes or inlets may be contributing to the problem.

Brush and vegetation overgrowth observed in the field appear to impede flow and should be cleared. Based on preliminary estimates, it is recommended that the existing 48 ft long, 24" culvert across 75th Street, and the 35 ft long, 15" culvert across Morningside Drive each be supplemented with a 24" cross culvert to improve conveyance capacity and reduce the frequency and extent of roadway flooding. At the time of detailed design, adequate analysis should be conducted to verify that the downstream impacts of proposed improvements are acceptable.

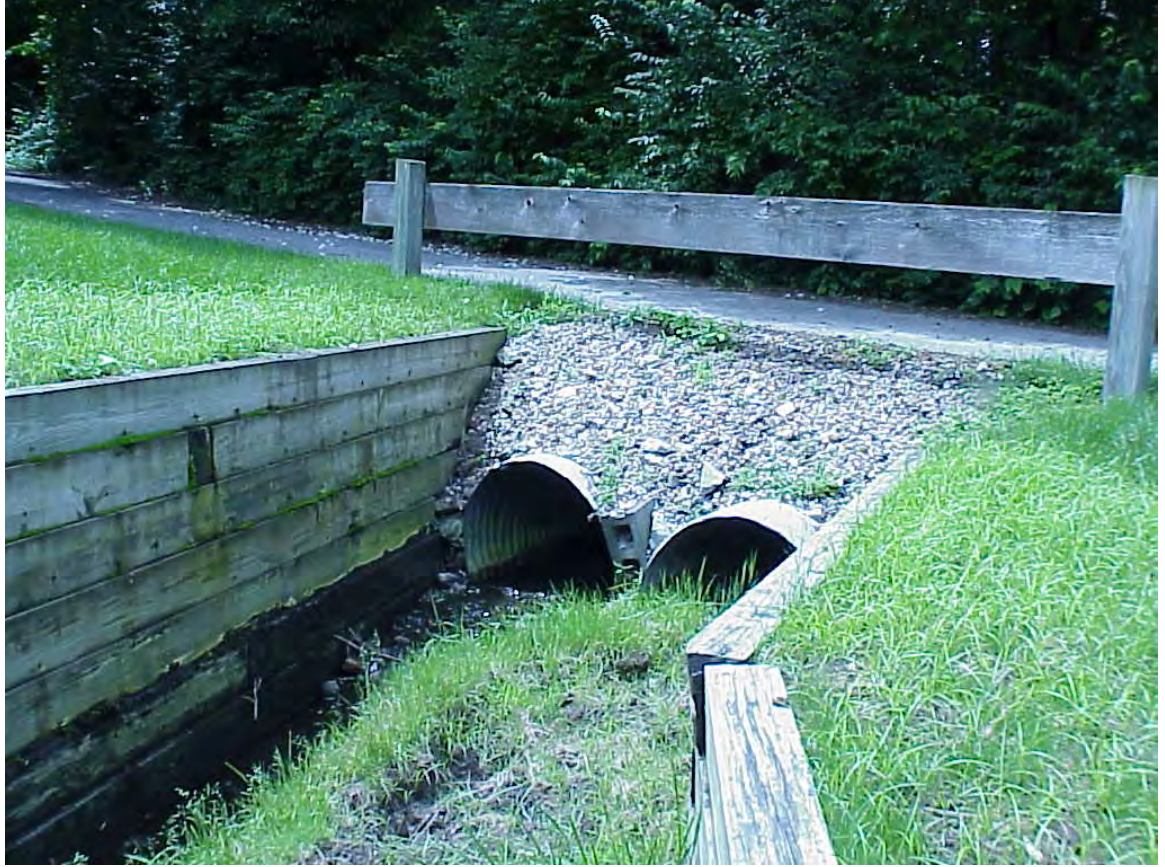
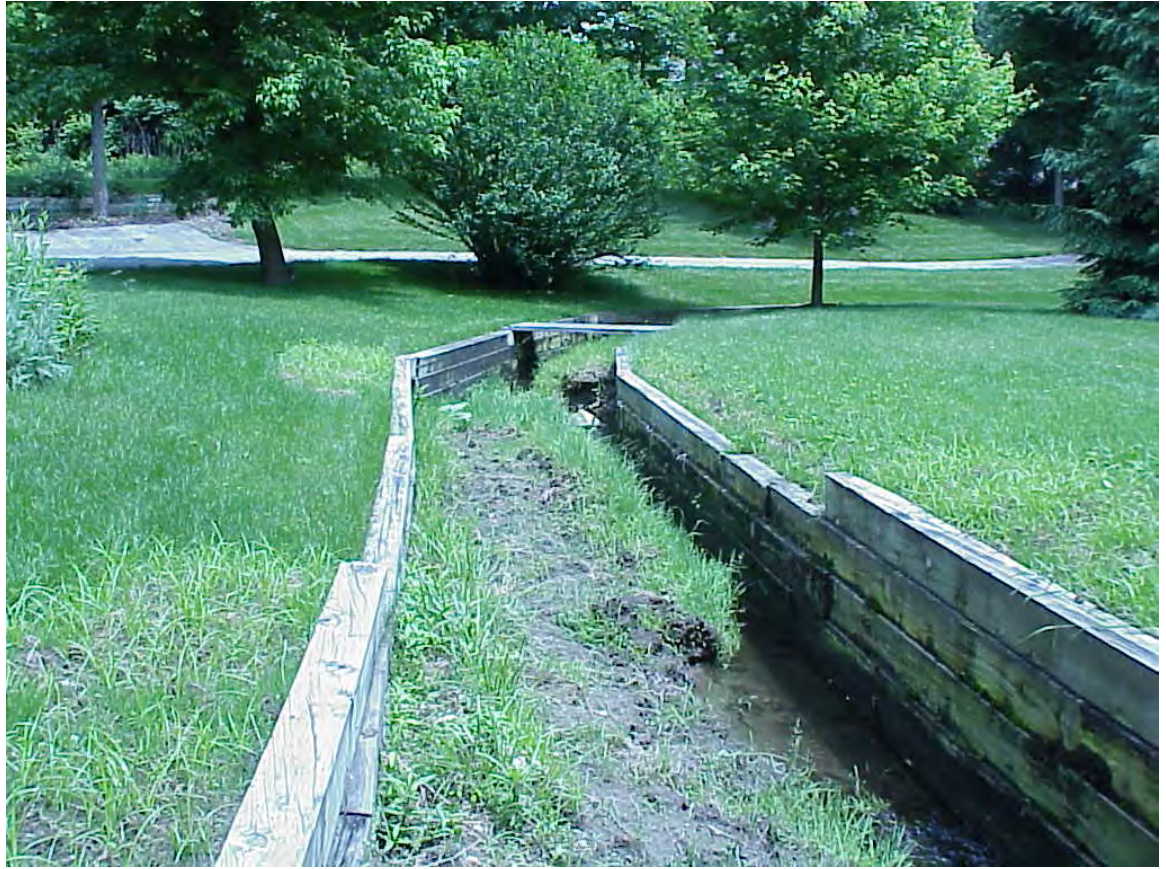
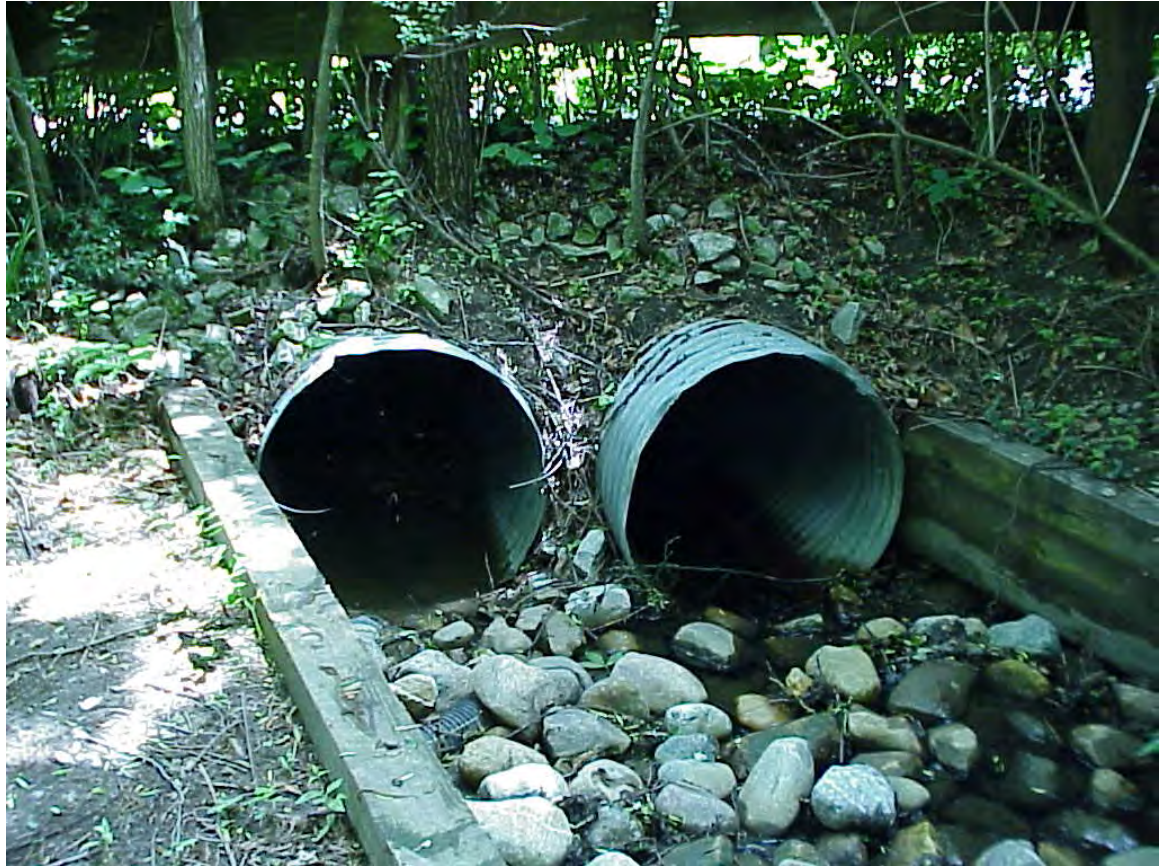
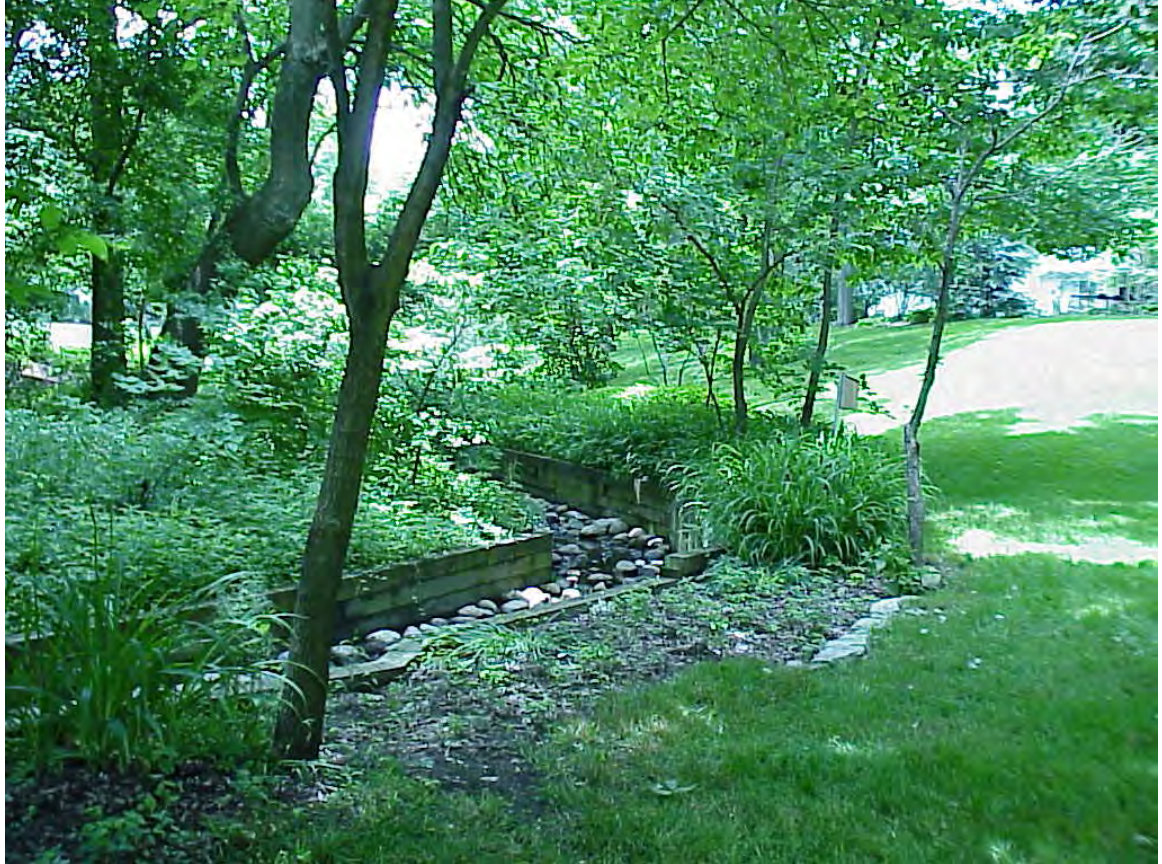
5. Penn Ridge and Washington

The area west of Penn Ridge and north of the waterway was reported by others to flood periodically. Approximately 118 acres drain to this problem area. The drainage area can potentially produce an estimated 10-year peak flow rate of 130 cfs, but the actual value may depend on the capacity of the existing system upstream. The existing culvert is a twin 36" CMP and the channel is roughly 6ft x 2.5ft rectangular in shape. It appears that the existing culvert and channel may not have sufficient capacity to convey the runoff without flooding. Without sufficient capacity in the culverts and downstream channel, it is likely that some water backup will continue to occur upstream (west) of the drive. However inadequate channel maintenance east of the culverts is creating problems.

It was observed that the existing culverts under Penn Ridge are silted, and the channel downstream (east) of Penn Ridge has not been properly maintained. Based on visual field observations, it is estimated that at least one third of the conveyance capacity has been lost due to lack of maintenance.

It is recommended that conveyance capacity in the channel and existing culvert under Penn Ridge be restored by cleaning the pipes and restoring the flow line in the channel downstream of the drive. It is also recommended that the entire system be periodically inspected and maintained as needed, especially after heavy rainfall events. It has been reported that the property owner was to maintain the system on his property. They should be required to do so promptly.

Conveyance capacity in the culverts may need to be increased. However, simply upgrading the size of the pipe may not be sufficient because the conveyance problem may also be present downstream (east) of the drive. Care should be taken not to transfer the flooding problem to downstream properties. Due to the size of the contributing area and potential impacts of various possible remedies, the Town should request a copy of the drainage plan submitted for the home and compare it to what was constructed.

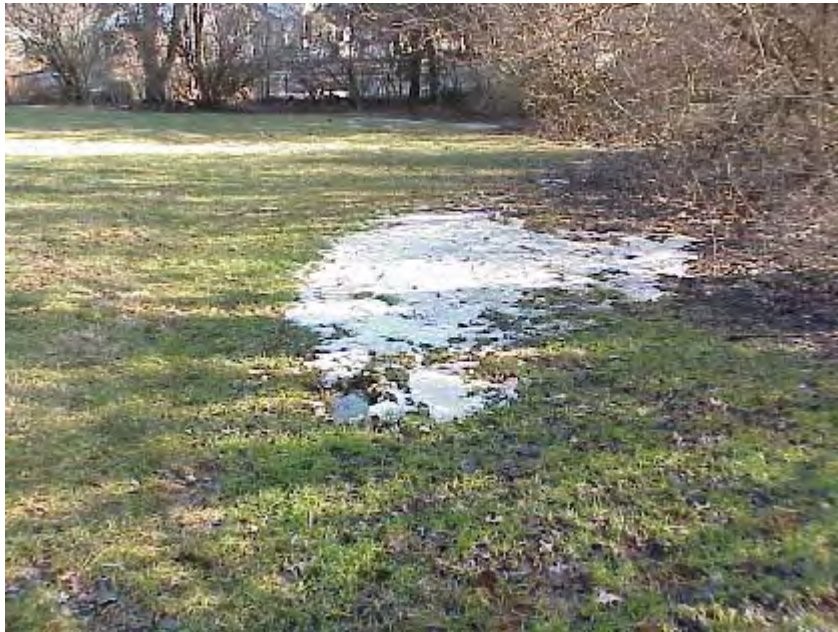
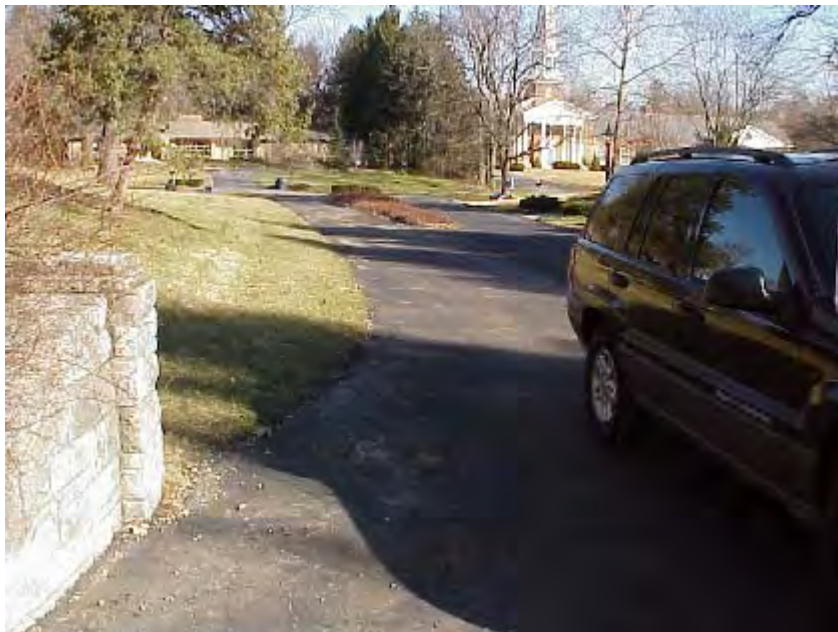
6. 7200 North Pennsylvania

Icy road conditions occur during the winter creating a road hazard. Although moderate to steep slopes on most of Pennsylvania Avenue generally allow for adequate drainage, poor drainage of the roadway surface in this relatively flat area appears to have resulted in shallow standing water in the roadway pavement and shoulder. Based on observations by others, the source of excess water is drainage from surrounding lots near 7200 Pennsylvania Avenue, and it does not include backwater from stream flooding. Approximately 14 acres (Area C5), with moderate to steep slopes, drain to the problem area, producing an estimated peak 10-year discharge of approximately 30 cfs.

To avoid standing water, and assuming that additional real estate is not available for stormwater storage, runoff must be effectively conveyed to the nearest waterway just south of the problem area.

Adequate conveyance can be addressed comprehensively if the road is rebuilt or repaved. The drainage inlets could then be properly sized to

prevent water from ponding on the pavement or shoulders. Until then, a storm sewer system along the road between 7200 Pennsylvania Avenue and an existing drain just south of 7150 Pennsylvania Avenue would improve drainage and reduce water ponding. The storm system would consist of a 30" to 42" RCP storm pipe approximately 420 feet long with several storm inlets placed at low points.

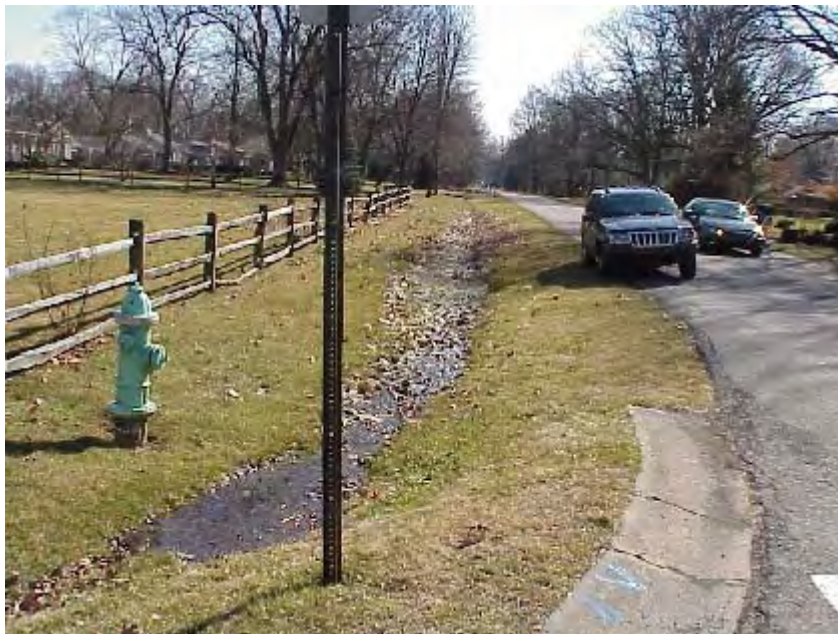
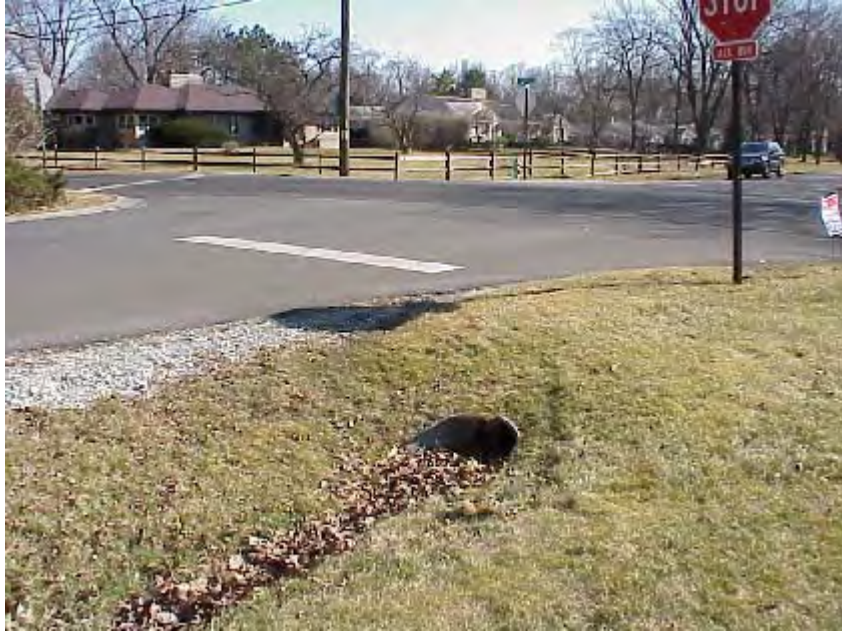
7. SE corner of 75th Street and Illinois Street

Water ponds near this corner and the ditches south of the area have been enclosed. The general area is flat. The drainage area that contributes surface runoff to this point is about 2 acres, and it generates relatively small runoff volumes. Periodic standing water in the roadway ditch appears to be due to flat slopes and lack of storm outlet.

A combination of ditch grading and new inlets connecting to the existing storm sewer along Illinois Street can address this problem. The ditch area to be graded varies in width between 5 and 10 feet. It extends from the northeast corner approximately 250 feet south along the east side of Illinois Street. Longitudinal and side slopes of 5% are desirable, and they should not be less than 2%. Standing water may still occur if the existing storm sewer capacity is limited, but it will drain, probably within hours, if the ditch grading and inlet locations are properly designed.

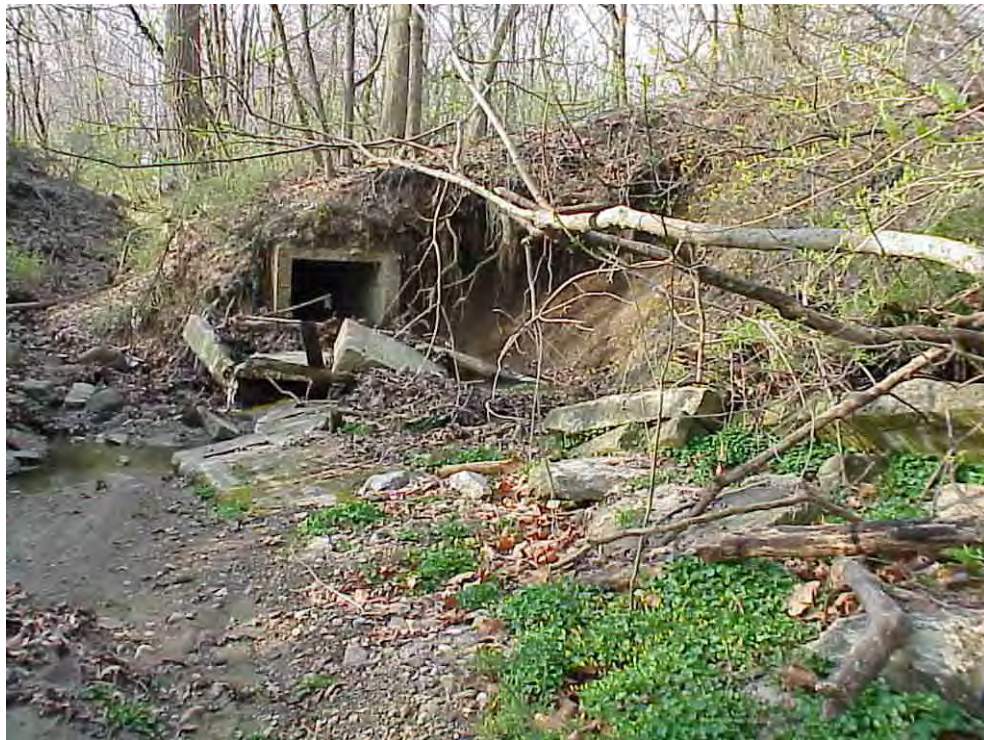
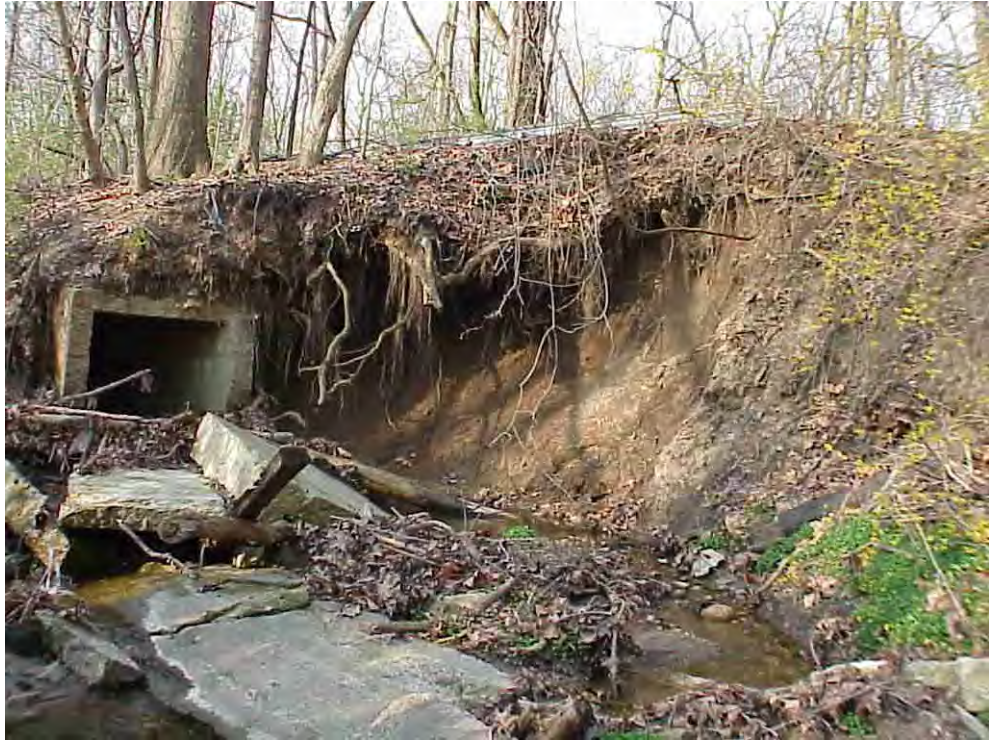
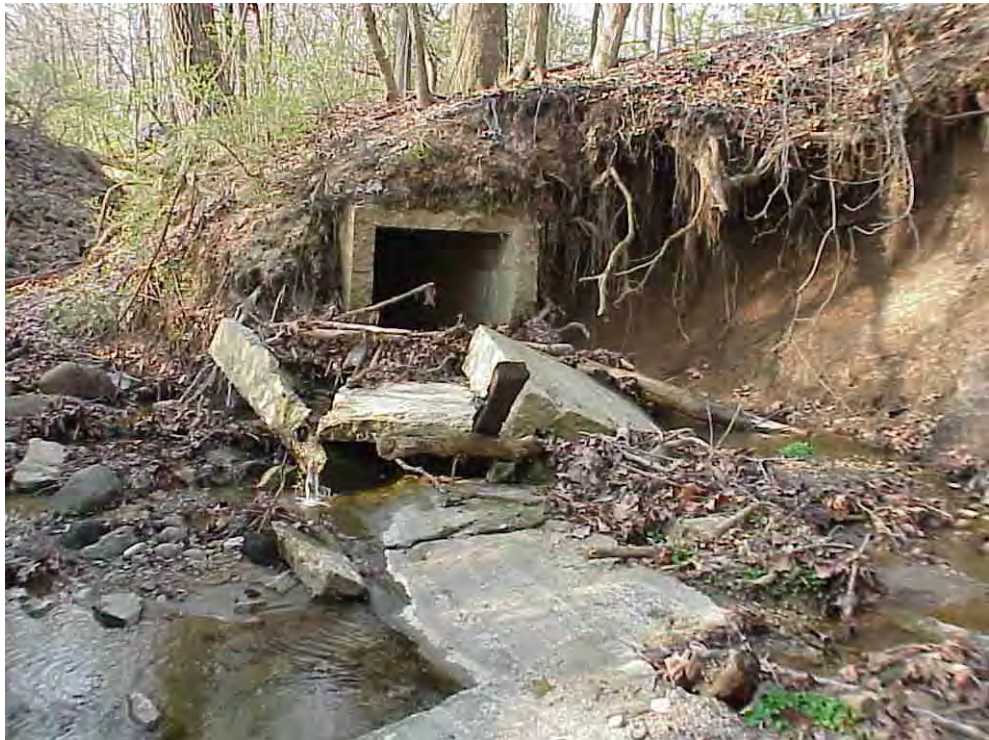
8. 7975 North Illinois Street

A box culvert has collapsed and is causing erosion that undermines additional sections of the culvert and threatens the guardrail and portions of Illinois Street. The drainage area contributing flow to this point is approximately 240 acres. Unlike storm sewers and driveway culverts that are typically designed to handle a 10-year design flow, major roadway cross culverts are typically designed to handle the 100-year design flow. The drainage area can produce an estimated 100-year flow of 250 cfs if upstream flows are unimpeded. The culvert is a 4 ft x 4 ft rectangular box, and the estimated 100-year flow velocities at the culvert could potentially reach 15 ft/s.

The broken pieces of the culvert should be relocated on the bottom of the channel away from the end of the culvert. Riprap gabions should be placed in unstable areas of the bank to reduce erosion. Work should clear only the vegetation necessary to place riprap and relocate broken culvert pieces. Access to the project area should be obtained from Second Presbyterian Church if possible.
