Town of Meridian Hills
Drainage Study Report

Prepared for:
Town of Meridian Hills

Prepared by:
The Schneider Corporation
Project No. 4918.002

July 12, 2004

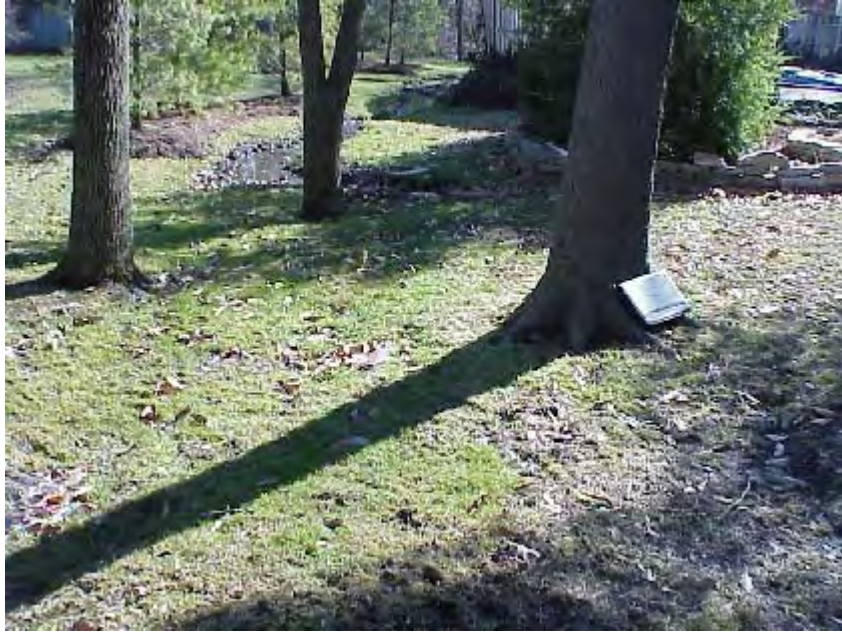
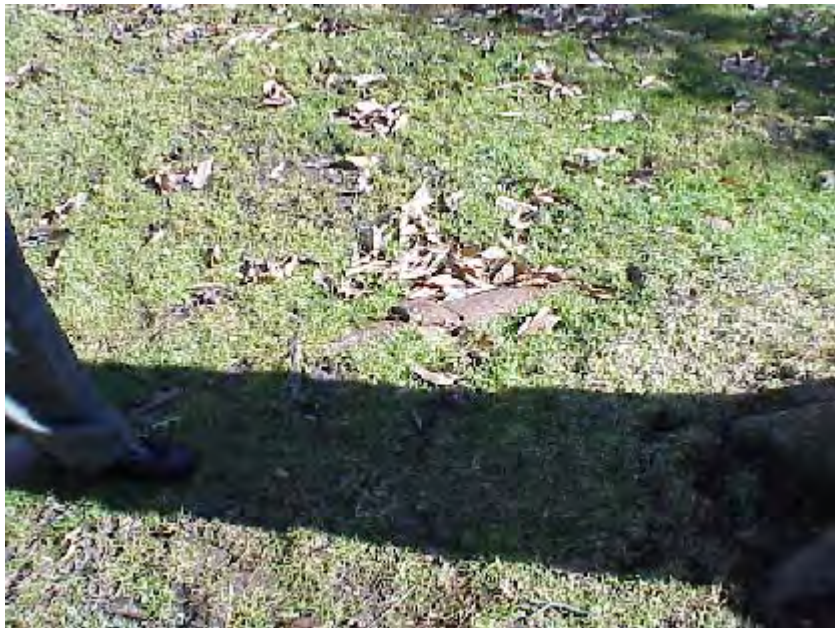
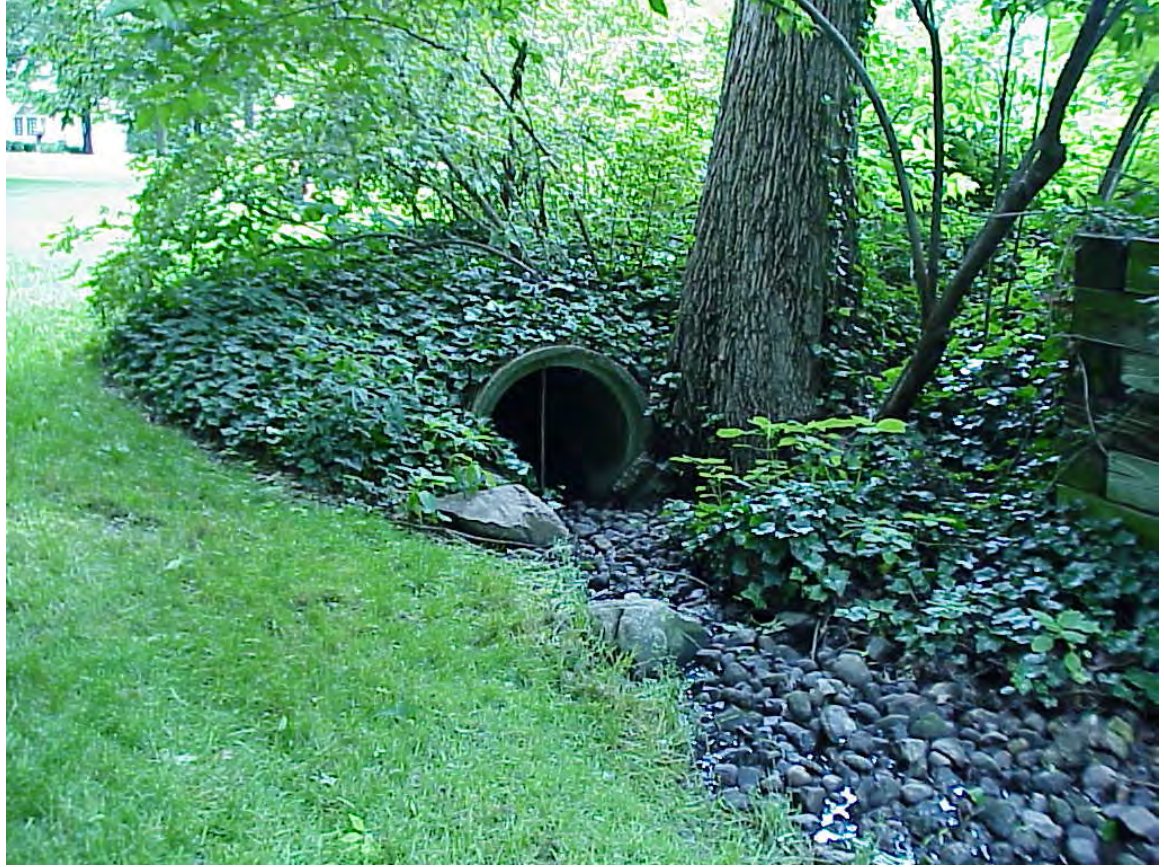
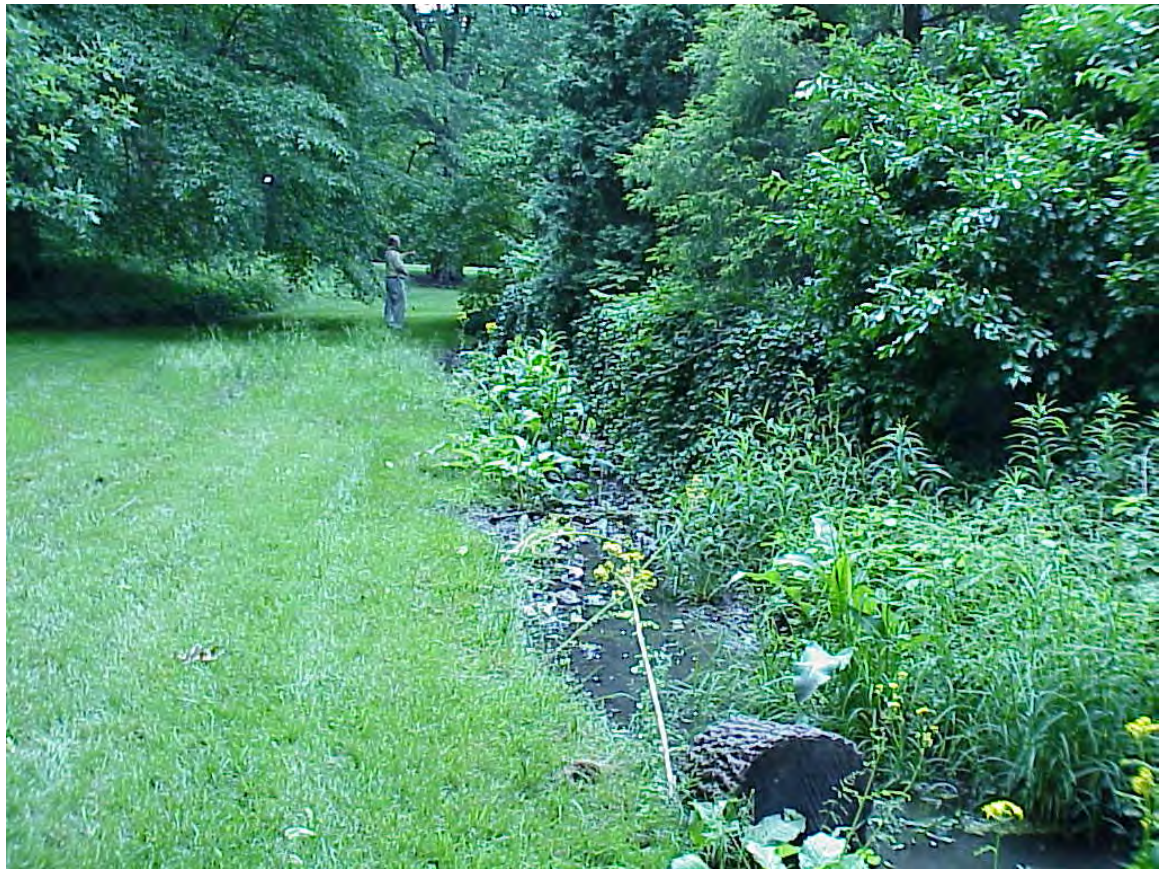
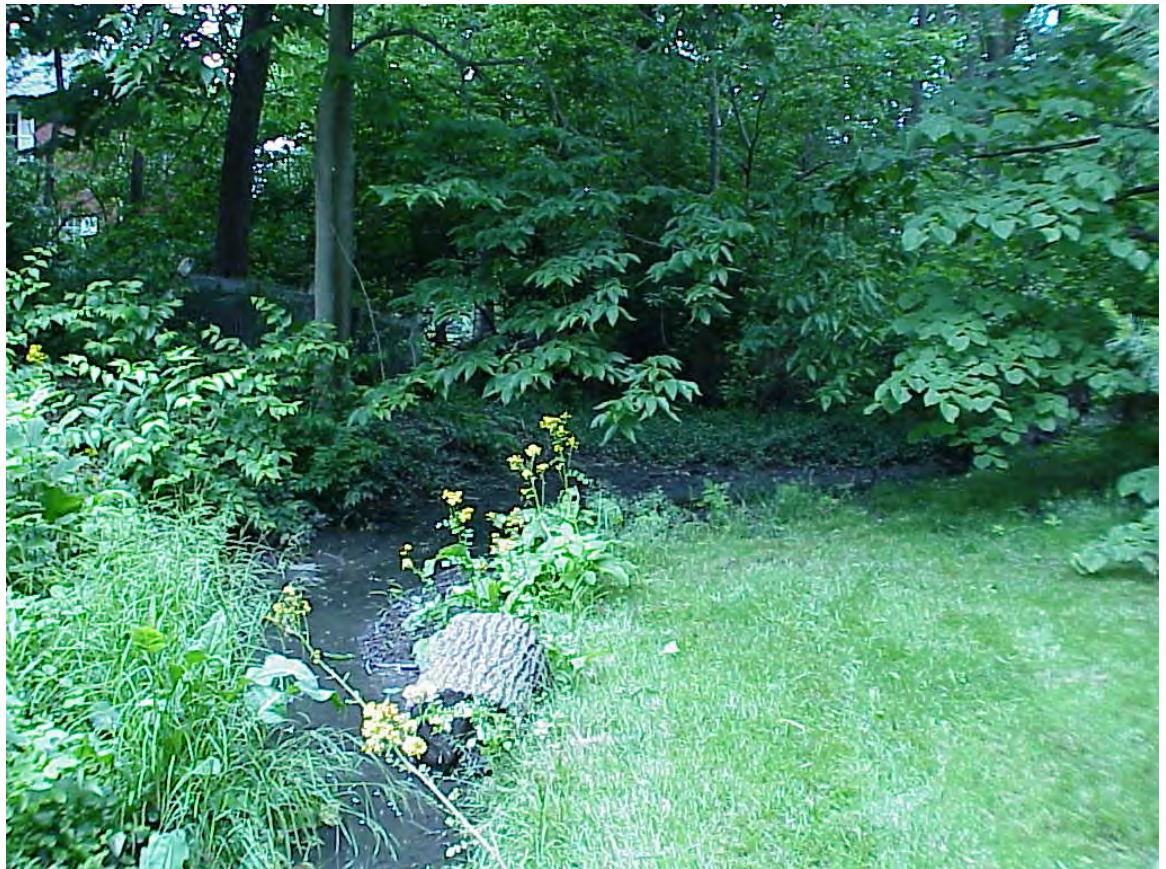
9. 7401 Holiday Drive East

Two problems exist at this location -significant standing water in the drainage way, and a broken tile in the backyard. Field observations indicate that standing water is primarily due to poor surface drainage, excess runoff from other areas, and inadequate outlet capacity.

The excess runoff and outlet capacity may be explained by the broken tile in the backyard. The tile takes flow from underground into a small surface ditch behind the home. The broken tile is only 6" deep, and has resulted in excess water on the property.

Poor surface drainage in the yard is due primarily to flat slopes.

The drainage area tributary to the drain at the problem area is approximately 36 acres. The 10-year peak flow can potentially be as high as 55cfs, although the actual flow may be lower due to limited capacity in the upstream sewer system. Overland flow likely conveys most of the flow, but it is clear that the broken pipe impedes some of the drainage.

The broken tile should be replaced and designed to daylight into the open ditch.

Poor surface drainage in the yard can be improved by regarding and stabilizing flat area to provide a positive slop towards the swale or inlets. Instead of a wide U-shaped area, a defined ditch line with ground side slopes of at least 1 % should be constructed to eliminate standing water.
